Missisquoi River Accessibility Assessments Report

Assessment #4, December 16th, 2024

Project: Outdoor Recreation Accessibility Initiative

Objective: Assess accessibility of water access sites along the Missisquoi River and develop

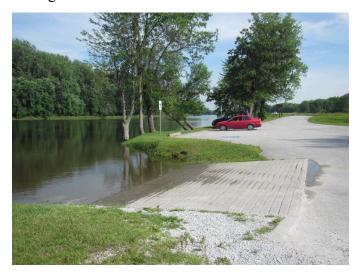
Figure 1. Figure 2.

Parking – Parking area is flat and wide, half pavement and half gravel. Two designated accessible parking spaces, at least one on both sections (Figures 1 & 2). Room for parking and turning around a trailer.

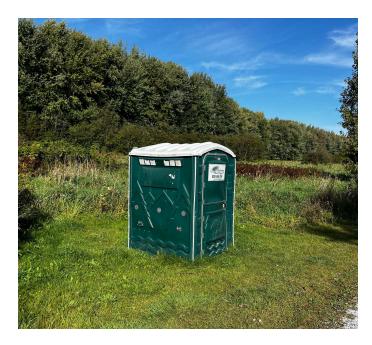
Figure 3.

Bathroom – There is no bathroom at Louie's Landing, but there is one a short walk away at Mac's Bend (~400-500' down a trail/road that starts as grass then transitions to gravel). There's a gate at Louie's Landing that is only open from September to December. When that gate is closed, there's a 46" wide gap to get through and access the trail. Restrooms also available at visitor's center down the road.

- Install benches along the main trail and near the water's edge.
- Add an accessible restroom at this access area so paddlers don't need to leave to find one.
- Secure unsafe areas near the water with railings or signage to prevent falls.
- Explore adding a small shelter or shaded seating for increased comfort.

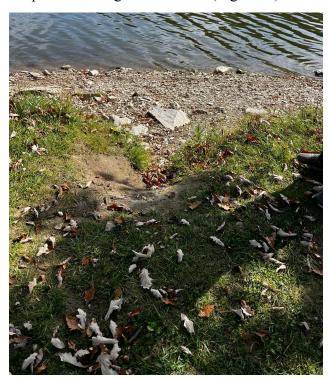
Figure 4.

Trail to Water $- \sim 85$ feet from parking area to water's edge with reasonable grades. Not really a "trail", just a flat, paved parking lot. Some informal trails leading down to the water as well with steep with loose gravel and dirt (Figure 4.)

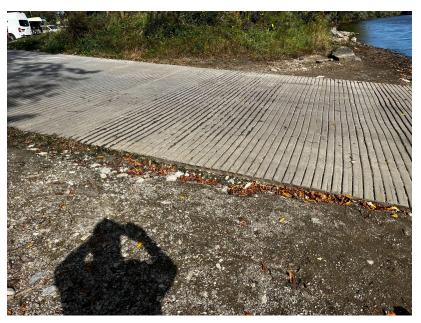
Figure 5.

Water Access – A 53-foot concrete boat ramp with a slope of less than 5% provides a generally accessible entry point. There are a handful of other informal access points leading down to the water that were established by people scrambling down the bank. They are somewhat steep, with loose rock and dirt so not very safe.

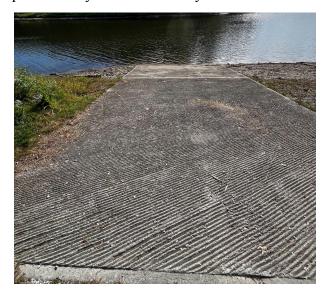
Figure 9. Figure 10.

Water Access – There are two concrete ramps present. Plenty wide (~15') and roughly 30' from start to water's edge. Continues 8 feet into the water. Steeper slope than Louie's Landing, greater than 5% grade. Room to launch multiple boats at once. Launch enters moving water. There's a place nearby to store mobility devices.

- Establish designated accessible parking spaces with clear signage.
- Add an accessible restroom at the site so paddlers don't have to travel to get to one.
- Determine if the ramp's grade is too steep; if so, come up with a solution to reduce it for improved accessibility.
- Add a wayfinding signage for clarity.

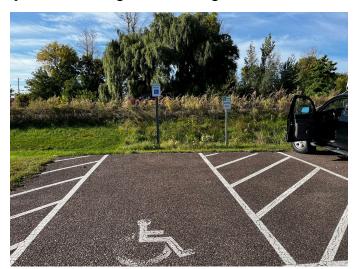
Figure 11. Figure 12.

Parking – Paved parking lot with one signed accessible parking spot. Tons of space in the lot, sufficient for turning around and parking trailers. There is a signed "Accessible Aisle" next to the spaces for loading and unloading.

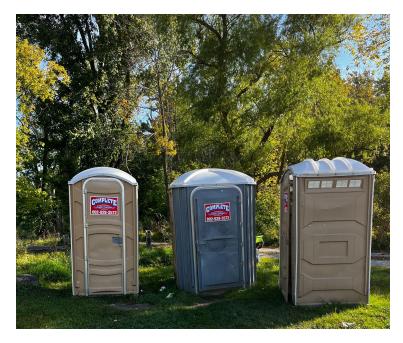
Figure 13.

Bathrooms – Three total restrooms, one of which is accessible. They are located in the parking area, roughly ~200' from the water's edge.

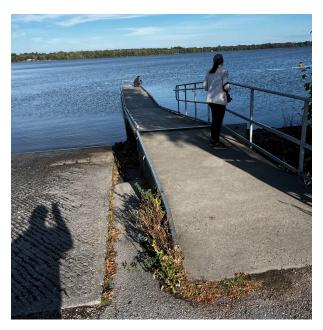
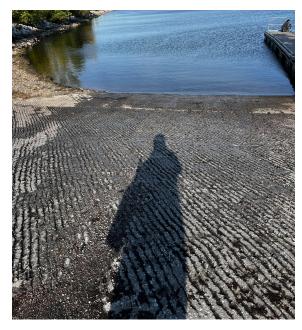
Figure 15. Figure 16.

Water Access – The concrete boat ramp is 30' long and very wide, with room for launching multiple boats at once. It has a \sim 11% grade and the concrete is grooved. There's a dock next to it, which is 40' long and wobbly. There's a large gravel beach to the left of the ramp with some scattered debris.

- Stabilize the dock to ensure safe use.
- Improve the informal gravel trail with firm surfacing.
- Consider adding shaded areas and debris cleanup at the beach.

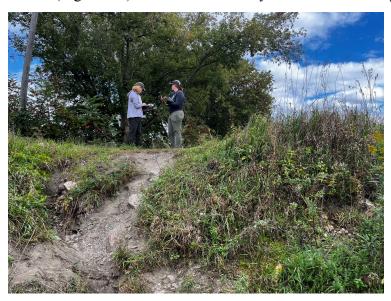
Figure 17.

Trail to Water -23' from the parking lot to the water's edge. Not a great access, basically a gravel washout. Steep grade, somewhat slippery footing, loose/protruding rocks and other debris, narrow (Figure 17.). Not suitable for anyone with a disability.

• No further investment; the site is not suitable for accessibility improvements.

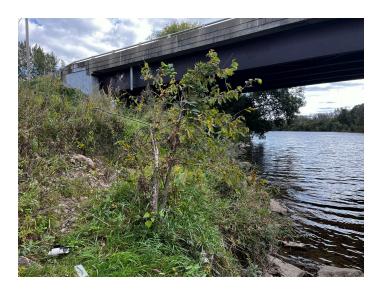
Figure 18.

Water Access – No established access, basically just a washout leading down to a dropoff into the water. Not very suitable for launching boats for anyone, let alone people with mobility issues or disabilities. Not much space on the river's edge to maneuver (Figure 18.).

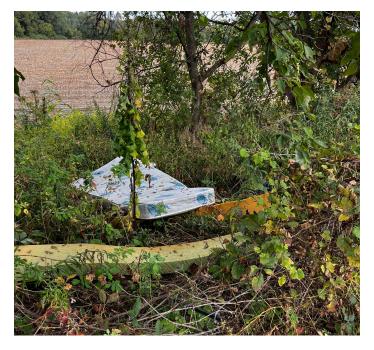
Figure 19.

Site Conditions – No shade. Minimally developed site, pretty rugged. Presence of dead animal and some trash dumped in woods nearby. Not busy at all. Noise from adjacent road. Site is maintained by Fish & Wildlife. Seems to have been used as a homeless encampment at some point in the recent past (Figure 19.).

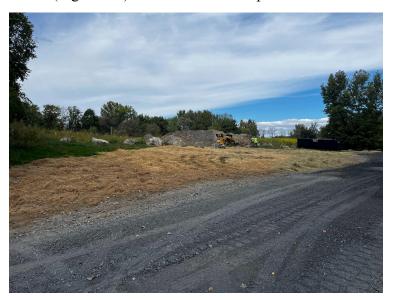
Figure 20.

Parking – Parking area is a mix of gravel and pavement. Currently under construction and being rebuilt (Figure 20.). Unsure of what improvements will be made but is currently closed.

• Reevaluate the site post-construction to incorporate accessible design elements.

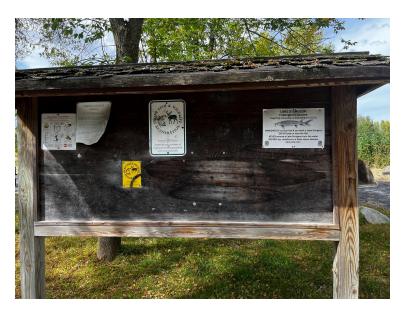
Figure 21.

Signage – There's a kiosk at the parking area, but it's kind of old and only has a few scattered signs (Figure 21.). Should be refreshed/updated with new signage.

- Add steps or a low-grade alternative to assist mobility-impaired users.
- Improve overall signage and create accessible parking zones.

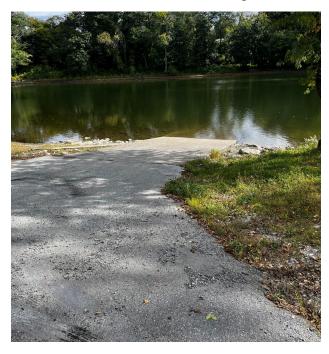
Figure 22.

Trail to Water – The trail to the water is basically just the asphalt boat ramp. 72' from start to water's edge and \sim 15' wide. Slope is greater than 5% but not too steep. Patches of asphalt that are also under construction and being fixed.

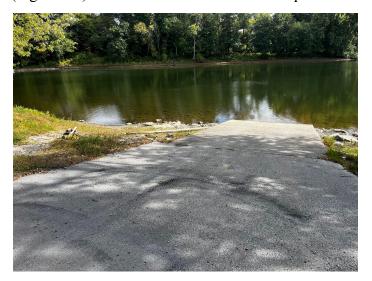
Figure 23. Figure 24.

Water Access – Water access comes at the end of the asphalt boat ramp. Plenty of space for multiple boats for launch at once. Steps would be beneficial on either side of the ramp. Second

put-in area as well that has some cracked asphalt, seems to have been damaged during flooding (Figure 24.). Could be rehabilitated and has potential to be a good accessible access.
