# Winooski Valley Accessibility Assessments Report

Assessment #1, September 10th, 2024

Project: Outdoor Recreation Accessibility Initiative

Objective: Assess accessibility of water access sites and develop recommendations for future improvements.

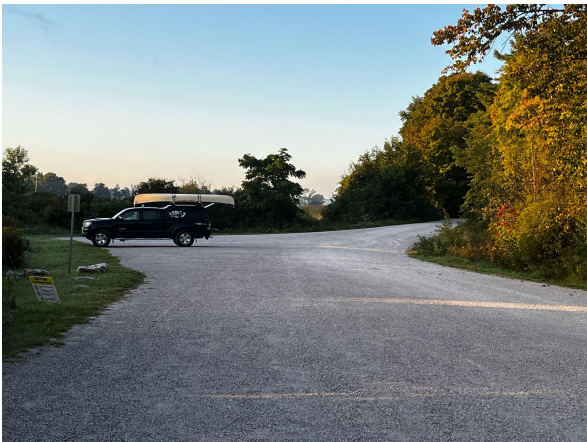
Figure 1.

**Parking Area** — There is ample space in the parking lot, making it feasible to establish multiple official accessible parking spaces. However, the current parking area is approximately 160 feet from the water, and the path down to the water has a slope of 14% (Figure 2.), which poses a challenge for accessibility. While there is no accessible bathroom on site year-round, Fish & Wildlife reportedly places a seasonal accessible bathroom. There is also room to create an accessible parking spot near the water (Figure 2, middle-left), which would mitigate the issue of the steep slope.

Parking — Build an accessible unloading/staging area or a dedicated parking space near the water in the grassy area to the left of the dock.

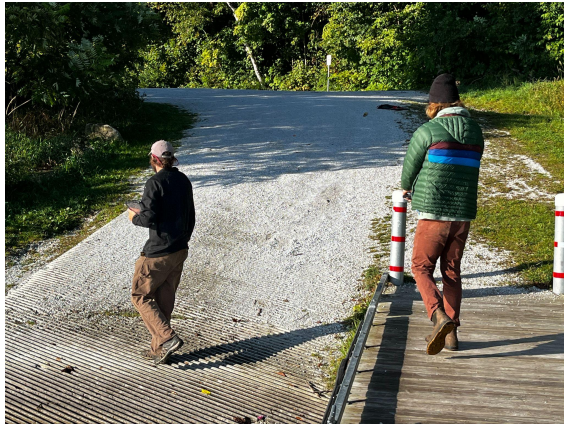
Figure 3.

**Trail to Water** — The trail leading to the water is wide, open, flat, and made of gravel, but the steepness of the slope makes it challenging for an accessible trail. A compliant accessible trail would need to be around 210 feet long, which might be difficult to achieve due to space constraints.

Trail Development — If feasible, develop an accessible trail from the current parking area down to the water. This would be challenging due to space limitations but could greatly improve accessibility.

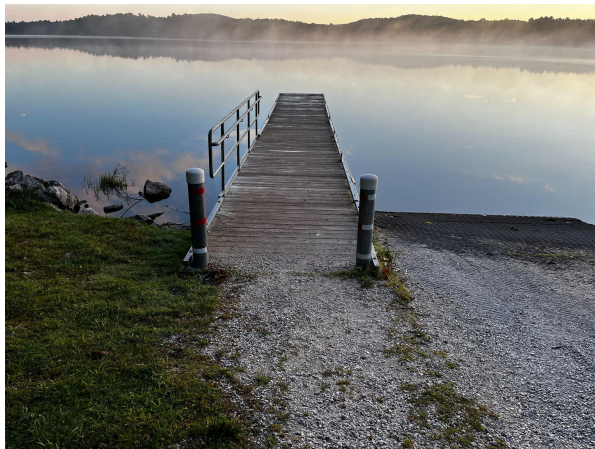
Figure 4.

Water Access Area — There is a 50-foot floating dock next to the boat ramp. Although there are bollards at the front, the 58-inch spacing between them is sufficient to accommodate a wheelchair (Figure 4.). However, there is currently a 24-inch gap between the top of the dock and the water, making it inaccessible for individuals with mobility challenges. The boat ramp itself has diagonal grooves in the concrete that could hinder wheelchair use, and there is a 6-inch lip from the boat ramp down to the gravel beach (Figure 5.). The site is well-developed, quiet, well-maintained, and located close to population centers, making it a strong candidate for improvement. It is managed by Vermont Fish & Wildlife, a long-term partner of our organization.

Dock & Water Access — Consider installing a lift on the dock or replacing the existing dock with an accessible one to bridge the gap between the dock and the water. Additionally, modifications to the boat ramp (e.g., smoothing out the diagonal grooves and eliminating the 6-inch lip) would facilitate easier water access for individuals using wheelchairs.

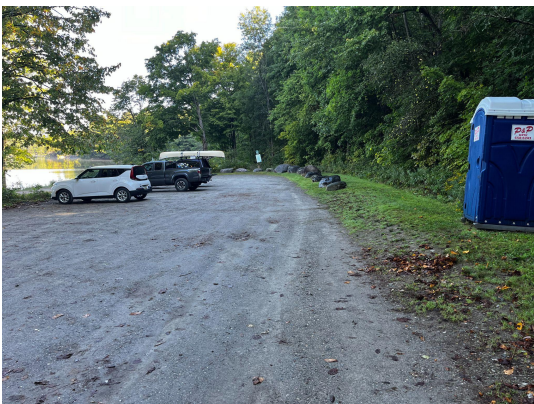
Parking Area — The parking lot is spacious, with one signed handicapped parking space (Figure 7.). However, this space could be better positioned for accessibility. The distance from the parking area to the water is about 70 feet. Currently, there is a non-accessible porta-potty on-site, which would need to be replaced for full accessibility (Figure 6.).

Figure 6. Existing portapotty

**Restrooms** — Replace the existing porta-potty with an accessible version, and ensure it is located near the accessible parking space for convenience.

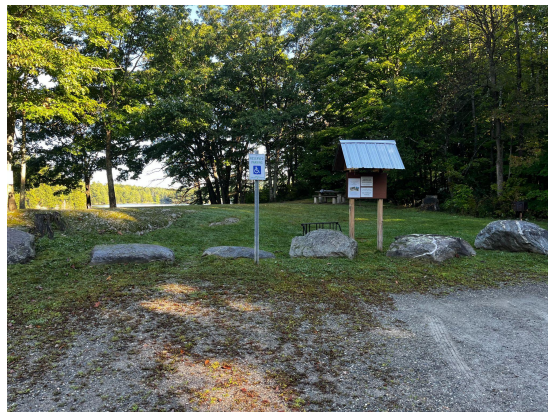
Figure 7. Designates accessible parking space

**Parking & Wayfinding** — Move the accessible parking space five feet to the left to provide more room for unloading and add a “No Parking” sign next to it to ensure the space remains clear for those with disabilities. Improve wayfinding signage on the road leading to the site to make it easier for visitors to locate the accessible parking area.

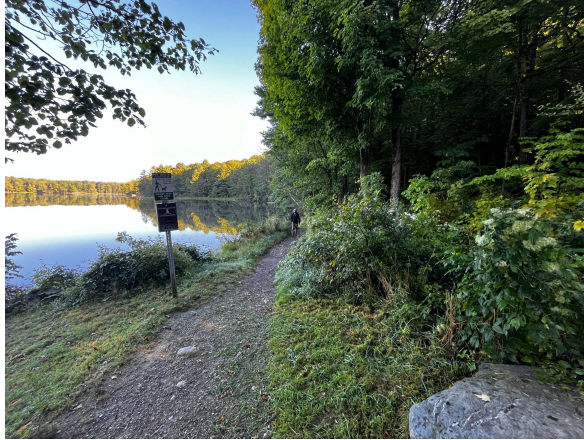
Put-in Areas — There are two put-in points at this site. The main boat launch has a slope that is too steep for accessible paddlers. However, the second put-in area is more suitable, as it features a relatively flat trail (5% grade) that leads 85 feet from the parking lot to a sandy water access

point (Figure 8.). This trail, however, has some small dips that need to be filled in or bridged, and there is a water seep from a small stream that needs to be diverted to prevent water from running into the put-in area (Figure 9.). Additionally, some branches and brush are encroaching into the trail corridor, which would need to be cleared. The area is quiet and shaded, which adds to the overall accessibility experience.

Figure 8. Widen & harden trail leading to water    Figure 9. Divert flowing water, harden put-in

**Trail Improvements** — Pave the trail leading to the accessible put-in area with compacted gravel, filling in the small dips and creating a smooth, level surface. Clear branches and brush from the trail corridor to ensure a wide, unobstructed path.

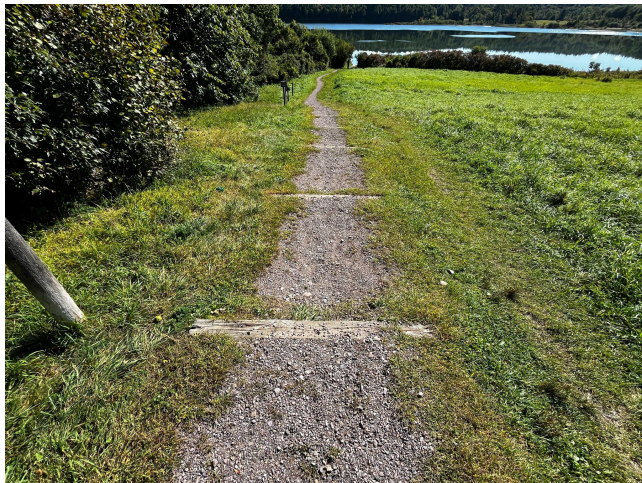
Figure 10.

Water Access Trails — Two trails lead from the parking area to the water. The main trail is 450 feet long but has several issues that limit accessibility (Figure 10.). It is narrow, with widths as small as 24 inches, has a 12% grade, and includes 10 timber check steps, which create barriers for individuals with mobility challenges. The alternative trail is more accessible, with a gentler 6% grade and no steps. There is also room at the site to reroute trails to improve accessibility.

Trail Enhancements — Add 8-10 more timber steps to the existing trail to normalize the rise/run to a manageable slope of 6%. Cribbing the steps would help with stabilization and safety. Consider rerouting the main trail to eliminate obstacles such as narrow widths and steep slopes. The second, more accessible trail should be improved, and the trail corridor should be pruned to provide a clear, wide path for all users.

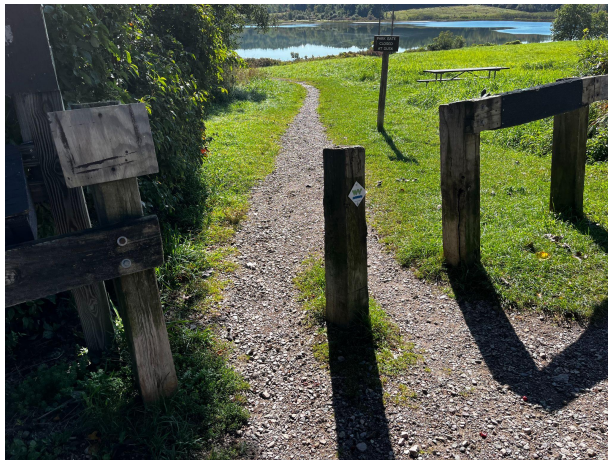
Figure 11.

Bollards — At the start of the trail, there is a set of bollards with gaps of 32 and 37 inches, which are too narrow for many wheelchair users.

Bollards — Widen the gaps between the bollards to at least 36 inches (ideally 42 inches or more) to accommodate wheelchair users and others with mobility challenges.

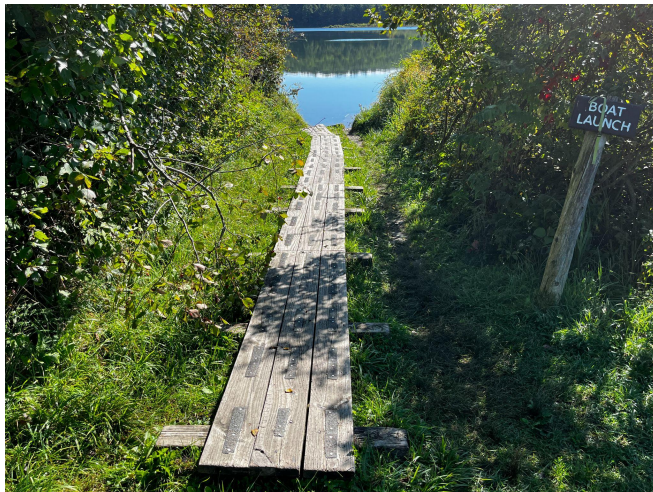
Figure 12.

**Bog Bridge** — A 50-foot bog bridge is present at the end of the trail, but it is in poor condition. The bridge has become twisted, and the boards have begun to rot, particularly toward the last section. The dock connected to the bog bridge is currently underwater, and the entire structure needs attention to make it safe and usable.

Bog Bridge & Dock — Repair the bog bridge, replacing the rotten boards and rebuilding the final section that has become twisted. Fix the gangway and consider replacing the existing dock, as it is currently underwater and unusable. A new, accessible dock would significantly improve water access for visitors with disabilities.

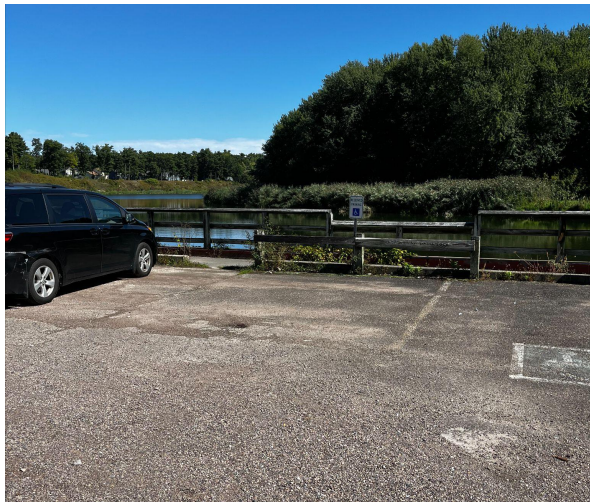
Figure 13.

Parking Area — The site has a large, flat parking area with two designated handicapped spaces (Figure 13.). There is room to establish more accessible spaces if needed. An accessible porta-potty is located nearby, and there is an informational kiosk (Figure 14.). However, one of the designated accessible spaces is missing its sign. The site is close to a population center and is generally quiet but can get busy during peak hours.

Parking & Signage — Install the missing accessible parking sign to ensure compliance with accessibility standards. Consider adding more designated accessible parking spaces if needed in the future, given the ample space available.

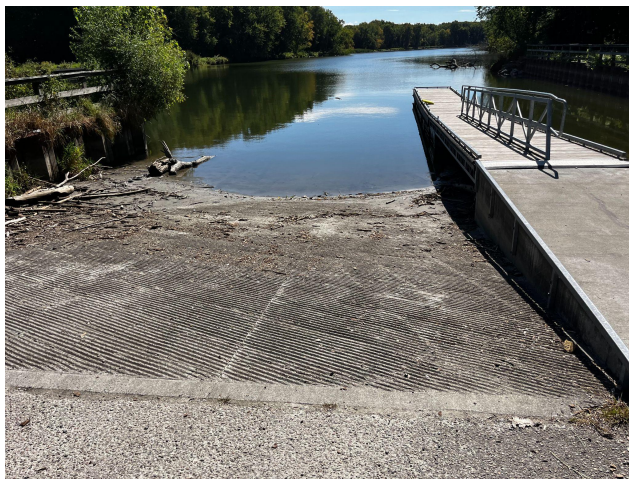
Figure 15.

Trail to Water — There is no formal trail to the water; instead, the large parking lot extends right up to the water's edge. The distance from the parking lot to the water is about 65 feet, with a slight 4% slope leading to the floating dock via a gangway. The boat ramp itself is steep, with a 15% grade, which could make it difficult for individuals with disabilities to access the water safely. The site is not shaded, so visitors are exposed to full sun.

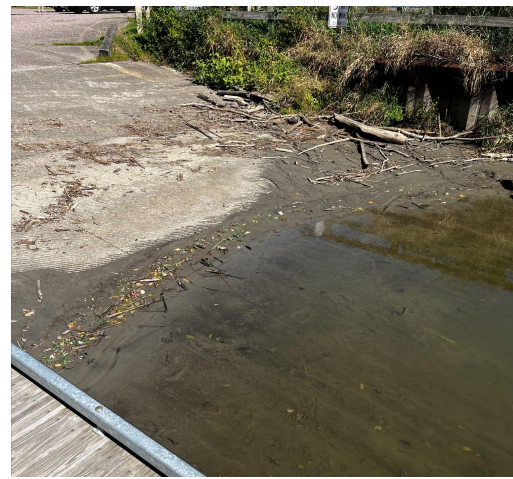
Figure 16.

Dock & Water Access — The floating dock is the primary access point to the water (Figure 16.), but modifications would be needed to make it more accessible to individuals with mobility challenges, particularly those using wheelchairs. The site also has a wooden fence along the water's edge, but the current railing height may not be accessible for wheelchair users who want to fish.

Dock Modifications — Modify the floating dock to improve accessibility, potentially by installing a lift or an EZ dock system, which would allow individuals with disabilities to access the water more easily and safely.

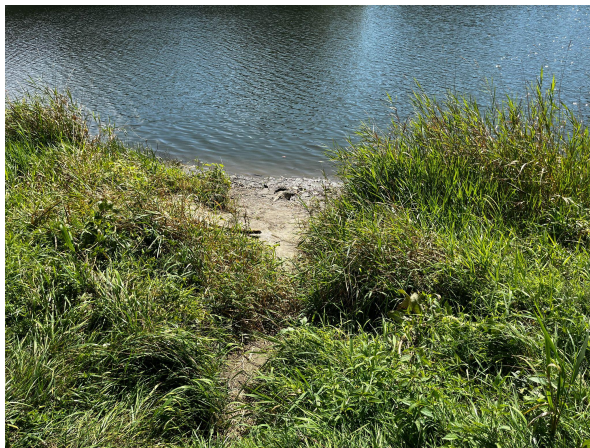
Figure 17.

**Trail to Water** — The trail leading from the parking lot to the water passes through an open, grassy field. It is about 100 feet long, relatively narrow, and has a gentle slope of 1%. However, once the trail reaches the top of the sandy bank, the slope becomes very steep (approximately 22%), and there is no established access infrastructure (Figures 17). The current path to the water is essentially a gullied-out bank that visitors scramble down (Figure 18.), which poses safety and accessibility challenges.

**Trail & Water Access Improvements** — To make this site accessible, the trail would need significant modifications. The most viable option for accessibility would involve using machinery to regrade the trail, creating a consistent 5% slope from the parking lot down to the

water. However, this approach would be very invasive and could detract from the natural aesthetic of the site. Seasonal flooding is also a challenge. Alternatively, building stone staircases could improve access for the general public, but this solution would not provide accessibility for individuals with disabilities.
